The Path to Accessible Multi-Use Trails

Prepared for Canadian National Institute for the Blind

University of Toronto

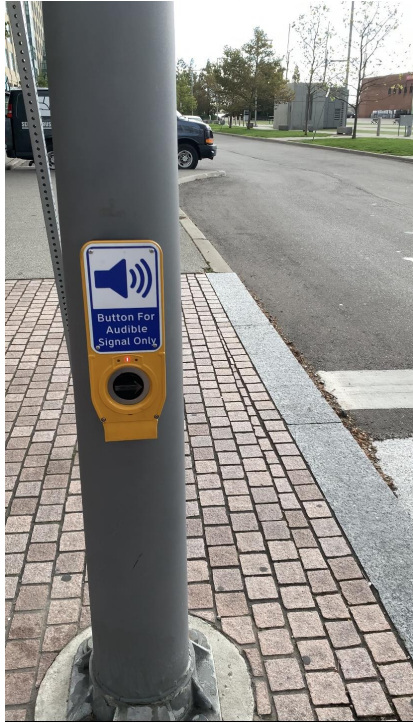
Figure 2: Accessible Pedestrian Signals at Crosswalk

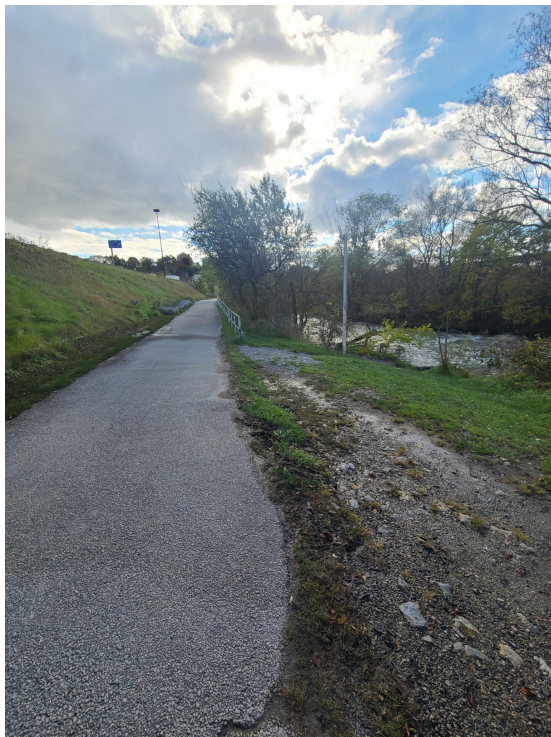
The Lower Don Valley Trail is a MUT that runs along the Don River. The trail is part of Toronto's Pan Am Path in the Ravine Trail Network, an 82 km trail across Toronto's legacy of the 1976 Pan Am and Parapan Am Games. After opening in 1961, the City of Toronto started planning improvements on the Lower Don Trail based on the Lower Don Masterplan in 2019. According to the City of Toronto, improvements are taking place to correct the fact that the trail is not fully accessible and, in some stretches, is unsafe for people belonging to certain disability groups. This trail was selected for assessment as it offers a good comparison of how the MUTAA performs when assessing more challenging trails compared to more accessible trails, such as the Martin Goodman Trail, which the City of Toronto has marked as being accessible.

Figure 5: Lower Don Valley Trail

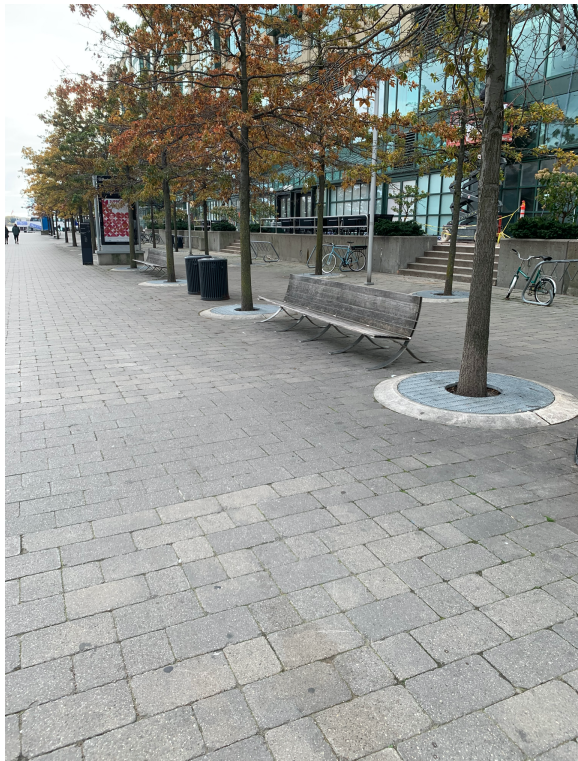
The strengths of the amenities found in the MUTAA include the resting areas and lighting which scored perfectly. There is an abundance of benches, resting areas, shelter, with light posts every 25-50 metres. Figure 6 shows a resting area with multiple benches.

Figure 6: Resting Area with Benches at the Waterfront Trail

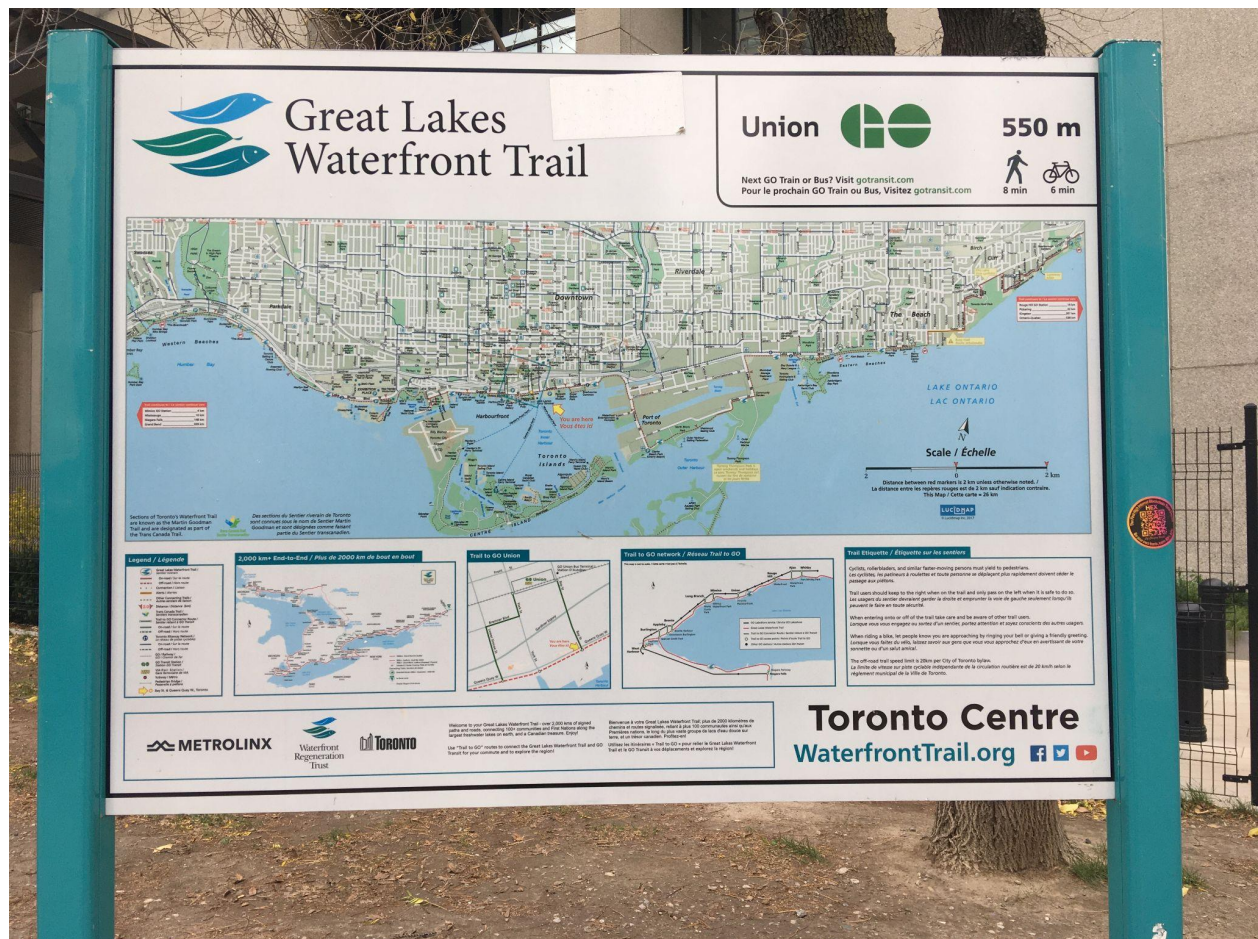
Figure 7: Wayfinding Signage on the Waterfront Trail

Wayfinding map signage was present at the beginning and end of the segment we assessed (spaced approximately 1.5 km apart). There is no information about hazards, slopes, surface type, or accessibility. The signs are also not designed in a very accessible way. Though

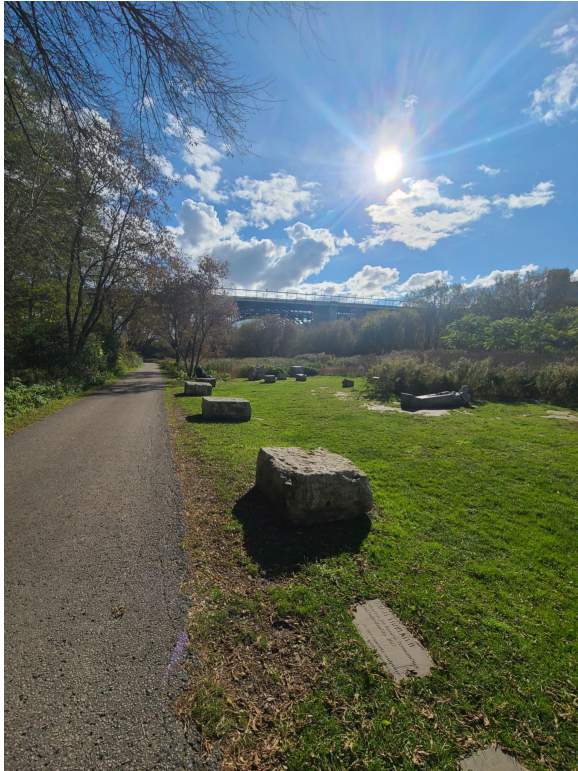
The most accessible components of the Don Valley trail are the physical characteristics. The surface of the trail was asphalt, making for a firm and stable trail. The trail width and access points were ranked well, with widths above the minimum AODA requirements. The trail was

relatively flat with an average running slope of 1.8%. One section of the trail was steep with an incline of 25.5% however, this section was marked as a hazard on the map located at the trailhead. When a steep slope is unavoidable, it is best practice to indicate a warning at the beginning of the trail to allow people with a disability, especially with a mobility impairment, to evaluate if the trail meets their needs. Additionally, the Don Valley trail had limited street crossing, making it accessible for persons with disabilities. Throughout the 3km section, there is one street crossing, and thus, users are safely protected from traffic. The Don Valley trail is most accessible during the spring, summer and fall since there is 3-season maintenance, where natural debris is removed from the path. During the winter there is no snow removal, making the trail challenging to navigate, especially for people with vision loss and mobility impairments.

Figure 8: Surface of Lower Don Valley Trail

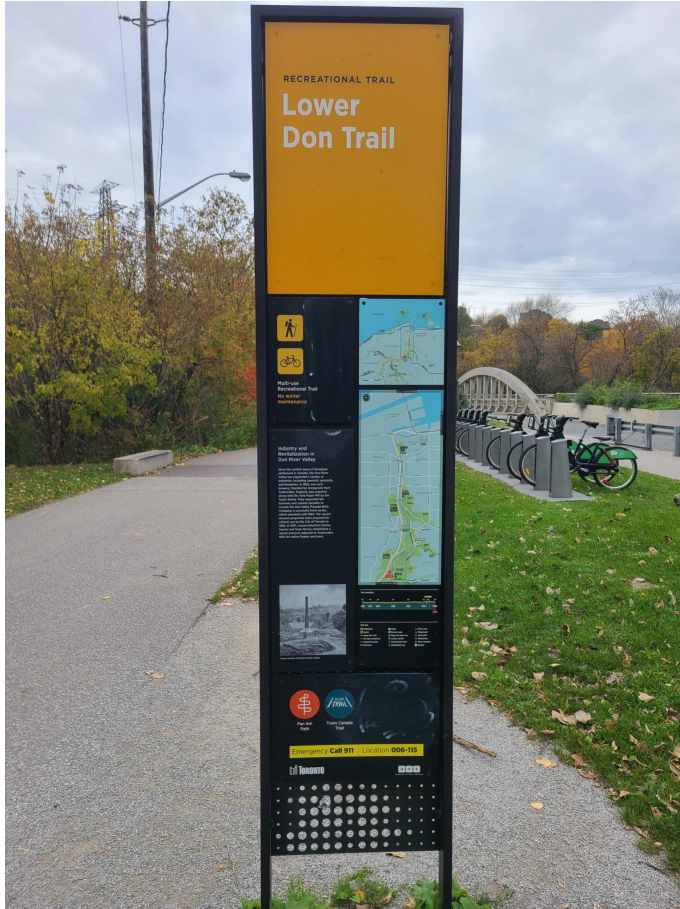
Overall, there was good signage located at the lower Don Valley trailhead. A map and accessibility information is present at the Pottery Road trailhead regarding the width of the trail, the average and maximum slope, and the trail surface. The map and textual information was displayed in a high tonal contrast, providing an accessible format for persons who have partial vision impairment; however there is no braille for users who have complete vision loss. Additionally, no guide ropes were found on the trail to help users with vision impairments. Providing online information in an accessible format can improve the signage and wayfinding of this MUT.

Figure 9: Map and Information at Lower Don Trailhead
