# Path of Travel and Restaurant Patios

This discussion paper will present guidelines for a path of travel, as well as present good and bad examples of patio barriers.

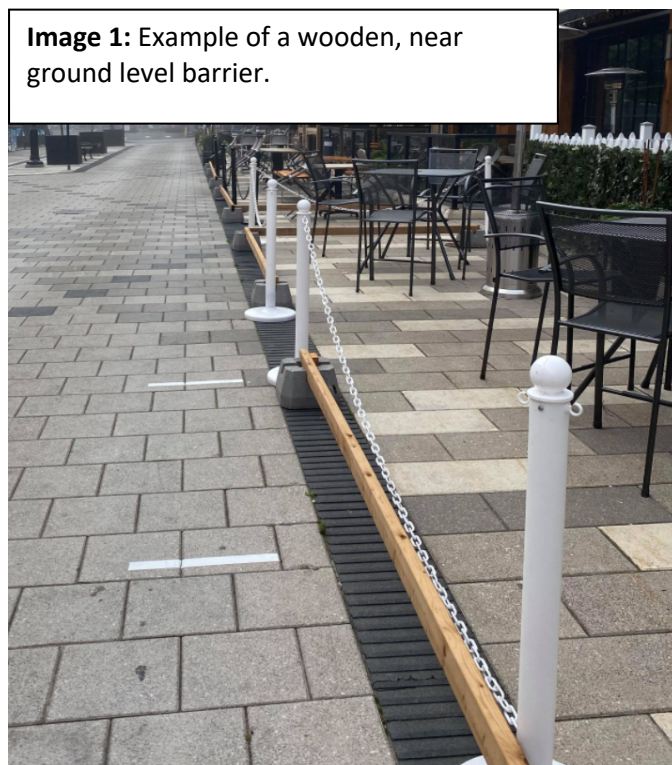
**Image 1** depicts a wooden, near ground level barrier, that is cane detectable. Typically, those who travel using a cane rely on their cane to detect objects below 680 mm. Therefore, it is important for patios and other temporary facilities to include ground level barriers to ensure the patio is cane detectable for people impacted by blindness or low vision navigating a path with a cane.

**Image 1:** Example of a wooden, near ground level barrier.

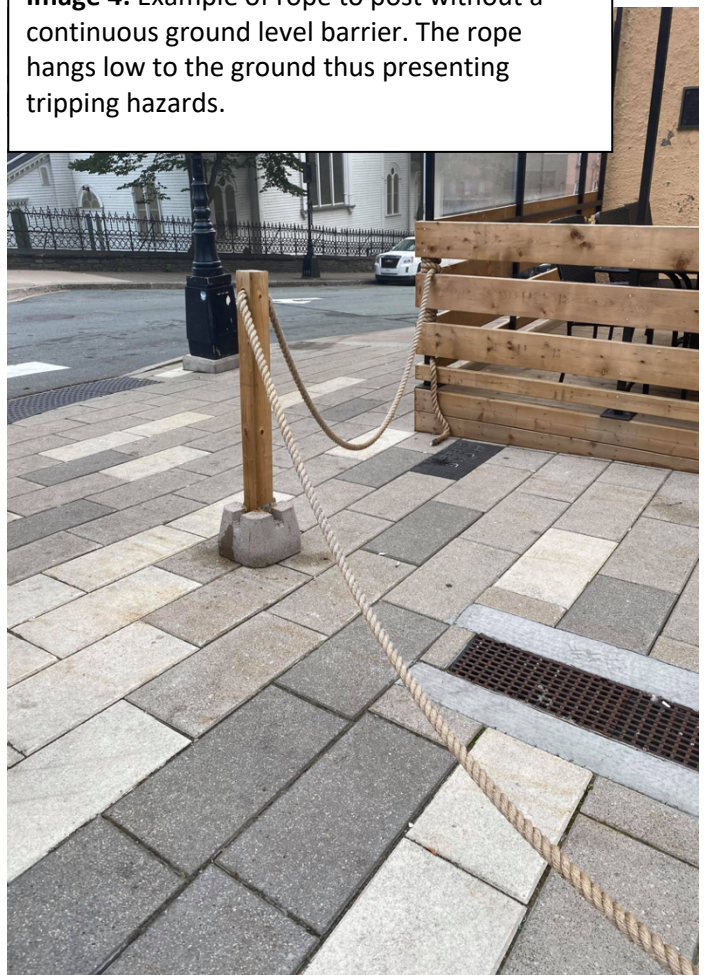
Similarly, to chain to post barriers, many patios also use a hanging rope connected by posts. **Image 4** depicts a thick and solid rope, however this barrier used to designate the patio is not cane detectable. The low hanging rope also presents a tripping hazard.

**Image 4:** Example of rope to post without a continuous ground level barrier. The rope hangs low to the ground thus presenting tripping hazards.

These types of barriers are not the best guidance for service dogs to follow. For example, in the summer of 2020, [a man in Sudbury Ontario who is visually impaired](#), walked into the middle of traffic due to his cane and guide dog being unable to navigate the path around the patio. The path had no curve or edge that he could feel with his cane and nothing for his guide dog to trail. This type of barrier creates accessibility concerns and should be avoided.

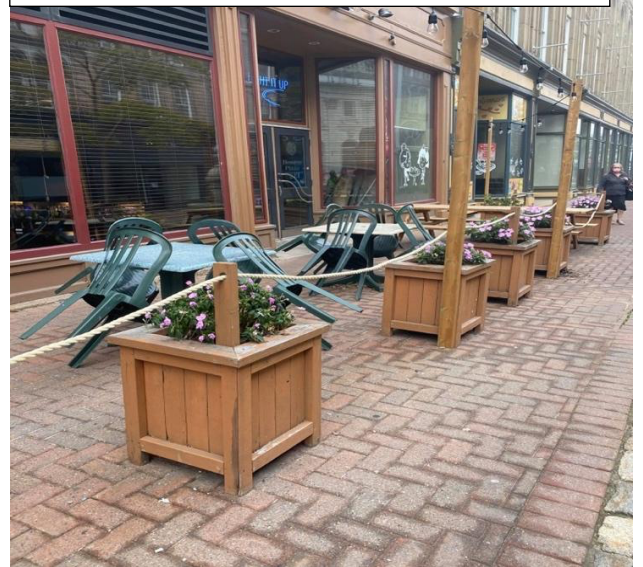
The patio in **Image 5** uses planter boxes to designate the patio, however each planter box is farther apart than the recommended 0.3 meters making the patio not detectable by cane.

**Image 5** depicts a different colored paving than the path of travel, using brick paving which provides color and texture contrast. **Image 6** has a black tactile strip that is detected by cane in front of the patio to separate the patio from the path of travel.

**Image 5:** Example of planter boxes connected by hanging rope to designate the patio.

To make the patio accessible, a toe rail should be a maximum of 680 mm from the ground and must be implemented to create a continuous cane detectable barrier. **Image 6** is an example of planter boxes that are distanced from one another but are accompanied by a toe rail thus creating a more detectable barrier.

Both examples do include hanging ropes that are placed at an appropriate height (i.e., not too low, not too high) to minimize safety hazards.

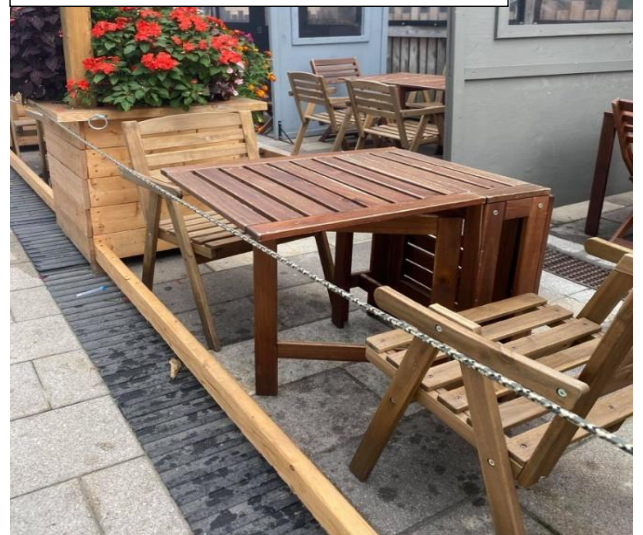
**Image 6:** Example of planter boxes that are distanced from one another but are accompanied by a toe rail.

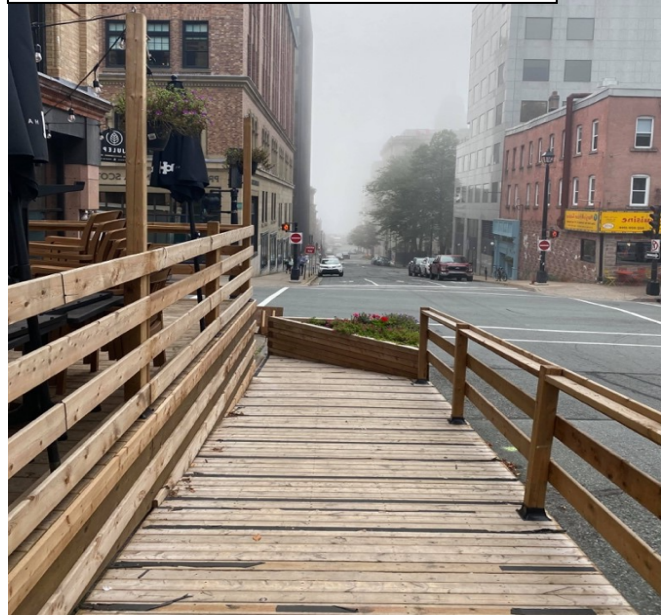
The sidewalks shown in **Image 7**, **Image 8** and **Image 9** are wide enough to accommodate an individual with a guide dog to move past a person using a wheelchair who is travelling in the opposite direction.

**Image 7** has a wooden fence to separate the sidewalk from the traffic. The fence includes a toe rail and a middle continuous firm barrier that runs along the fence to safely separate pedestrians from the road. Entering and exiting the sidewalk extension is made easier due to the rotated planter box guiding pedestrians on and off the sidewalk. The fence also contrasts well with the sidewalk extension and the road.

**Image 7:** Example of a sidewalk extension with a wooden fence. The sidewalk is slightly slanted.

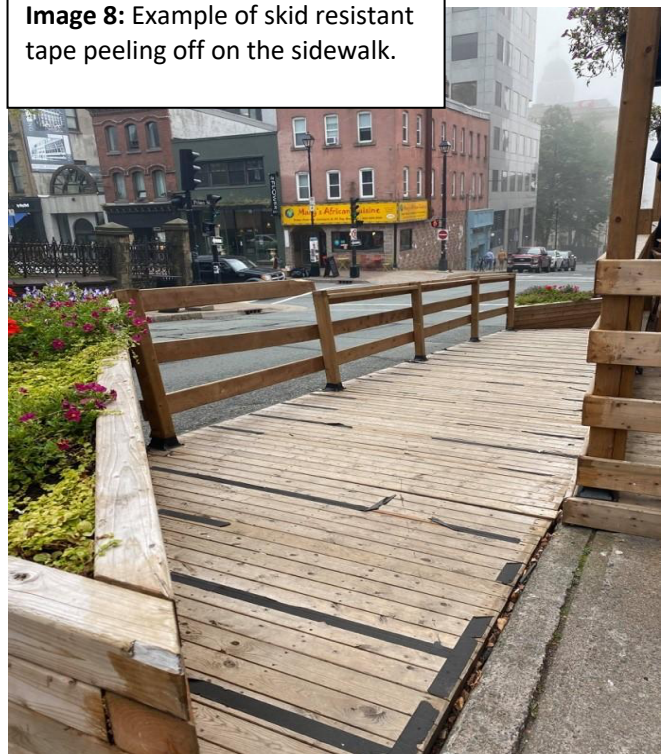
The sidewalks however, could be enhanced by regular maintenance practices. The skid resistant tape on the sidewalk extensions can pose accessibility issues especially for wheelchair users. The pieces of tape peeling off the wood can reduce grip for those navigating with a wheelchair and may be a tripping hazard for pedestrians of all abilities.

**Image 8:** Example of skid resistant tape peeling off on the sidewalk.

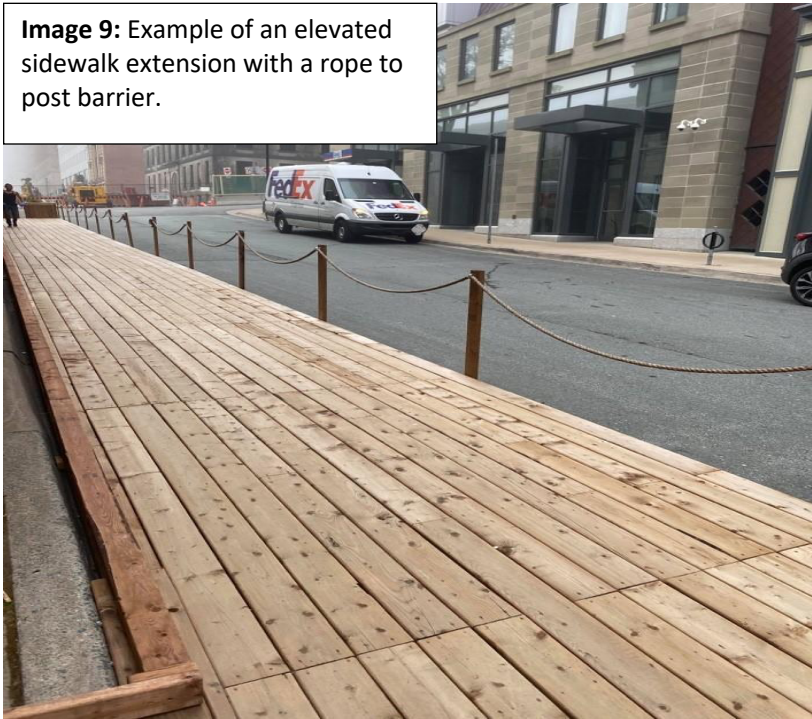
**Image 9** has a rope to post barrier to separate from the road. The sidewalk extension is slightly elevated; therefore, cane users can detect the edge. The rope is also at an appropriate height making it easy to trail the rope by hand. Furthermore, the posts contrast well with the sidewalk extension and the road. The sidewalk is also very wide, free of obstructions and has a smooth, well-maintained surface.

**Image 9:** Example of an elevated sidewalk extension with a rope to post barrier.

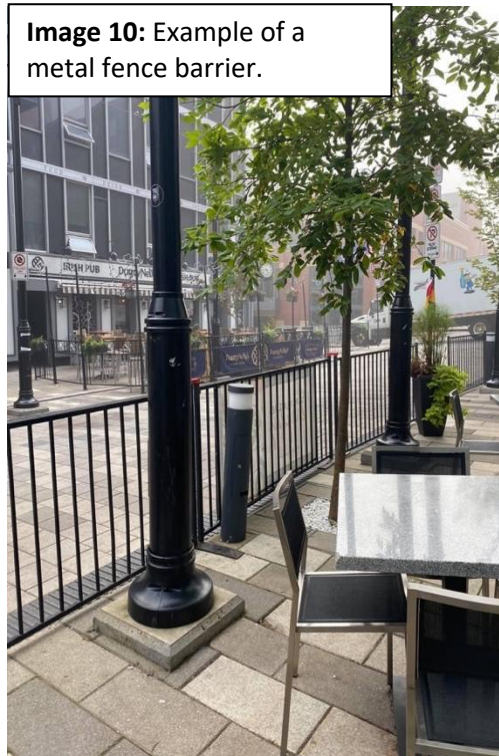
Metal fencing is a common barrier to designate a patio. The black color of the fence contrasts well with the ground. The fence is tall enough to use as a guide and the fence is solid and sturdy. The fence is cane detectable.

It is important to note that many metal fences such as shown in **Images 10, 11** and **12** typically have openings between the poles. For people travelling with a cane, the cane can potentially get stuck in between the openings.

**Image 10:** Example of a metal fence barrier.

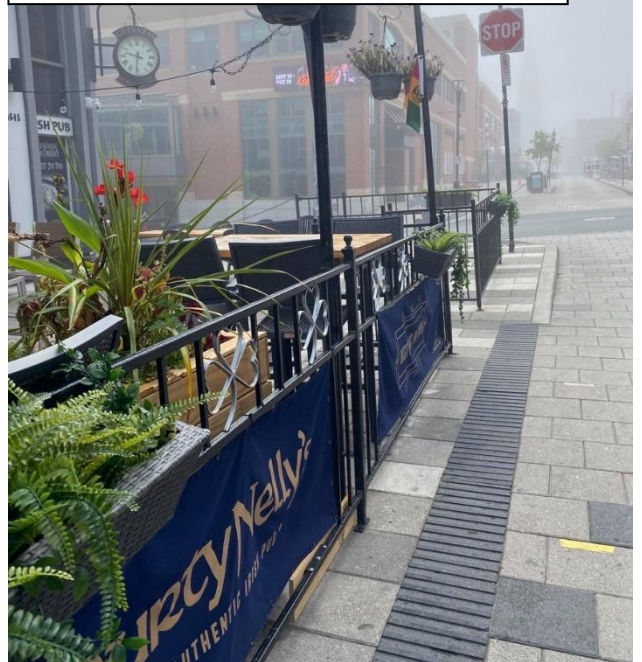
Some patios also include beautification elements such as enhancing their fence with hanging flower pots as shown in **Image 12**.

Overhanging objects and plantings within building landscapes should be no lower than 2,030 mm (2.03m) along walking routes. Elements that are lower than 2,030 mm such as greenery on fences should not protrude more than 100 mm (0.1m).

**Image 12** depicts a patio that has been enhanced using greenery. The use of elements adheres to the measurement guidelines stated above.

**Image 12:** Example of fence with decoration elements (hanging flowerpots on fence and overhead plants).

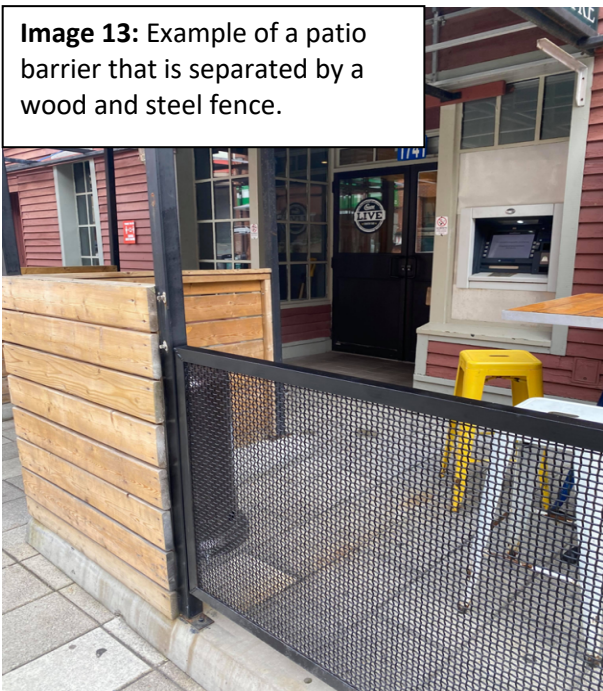
The patio barrier includes both wood and steel fencing. The patio is cane detectable due to the ground level continuous barrier. The fence is enclosed with no open spaces except for the entrance and exist paths. Furthermore, the patio is much easier to identify and navigate compared to a typical chain/rope to post barrier due to its large size and adequate color contrast to its surrounding areas. There is a wide path of travel directly in front of the patio with no obstacles or obstructions, thus making entry to the patio and walking past the patio easy to navigate.

**Image 13:** Example of a patio barrier that is separated by a wood and steel fence.

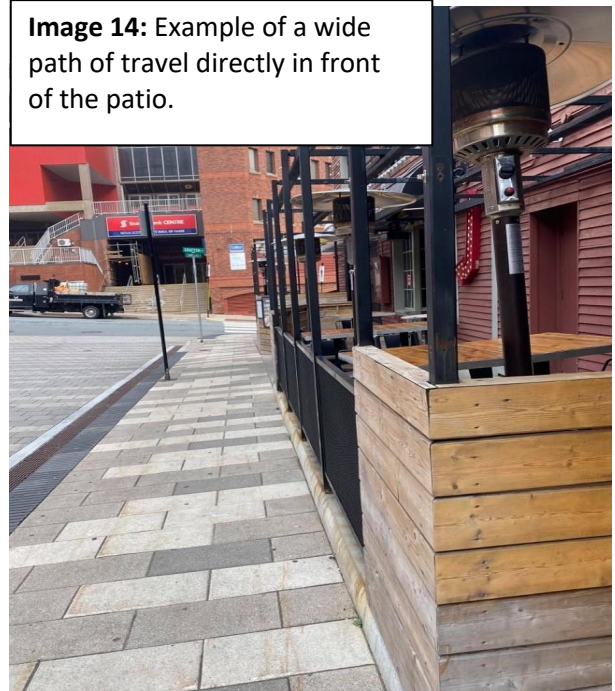
**Image 14:** Example of a wide path of travel directly in front of the patio.
